CENTER FOR ENERGY AND ENVIRONMENT RESEARCH  
UNIVERSITY OF PUERTO RICO

# Oceanic Corrosion Test of Bare and Zinc-Protected Aluminum Alloys for Seawater Heat Exchangers

November, 1982

Prepared for National Aeronautics  
and  
Space Administration  
under  
Grant No. NAGW-198

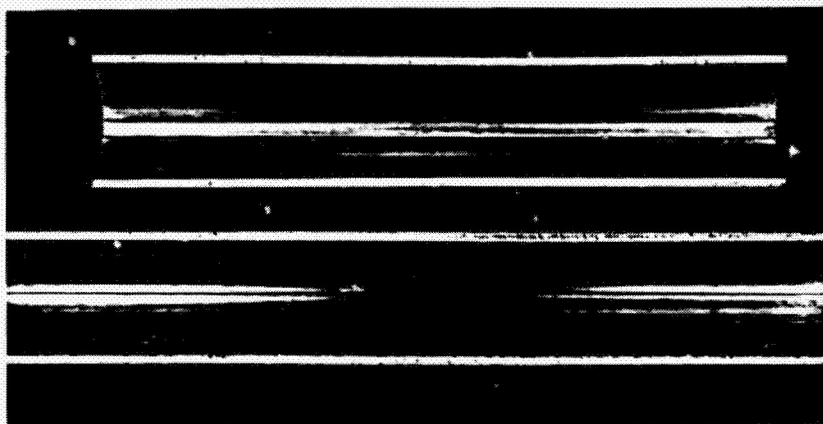
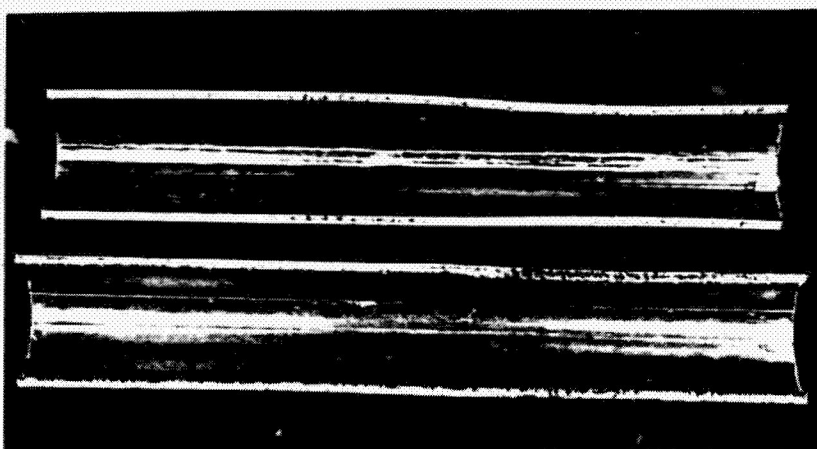
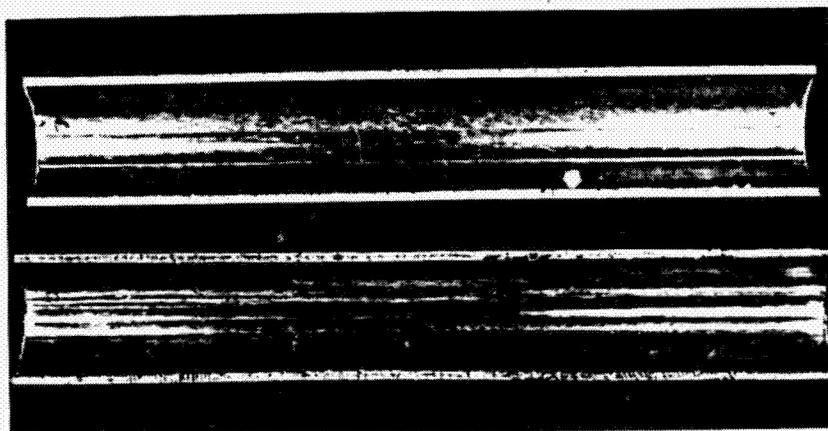
FIGURE 16. Surface appearance, RFW tubing, 185 days exposure.  
Magnification 0.6X.

9.1.2.1 RFW TUBING. Figure 16a-c displays macro-photos of the inner surfaces of the three types of RFW tubing exposed for 185 days. Figure 17a-c displays 2X photos of the same tubes in the weld area. These samples typify the surface condition of all RFW tubes tested. Corrosion was uniform, with pitting observed in only two of the 42 tubes. There was no selective attack of the weld or heat-affected zone, and no evidence of cavitation or erosion-corrosion. Figure 18 displays 100X metallographic cross sections of the three types of RFW tubes after 185 days exposure, showing smoothly corroded surfaces and the absence of pitting.

a. Bare 3004 (A-23)  
32 brush passes

b. 5% Alclad 3004 (B-29)  
Chlorinated

c. 10% Alclad 3004  
(C-111) 32 brush  
passes

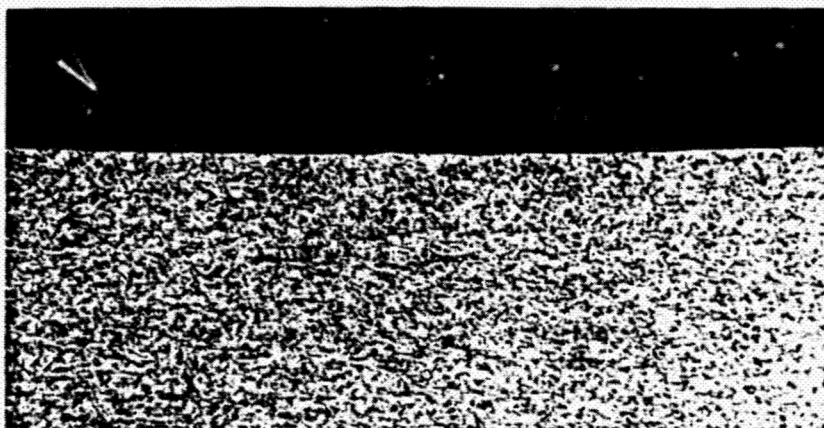
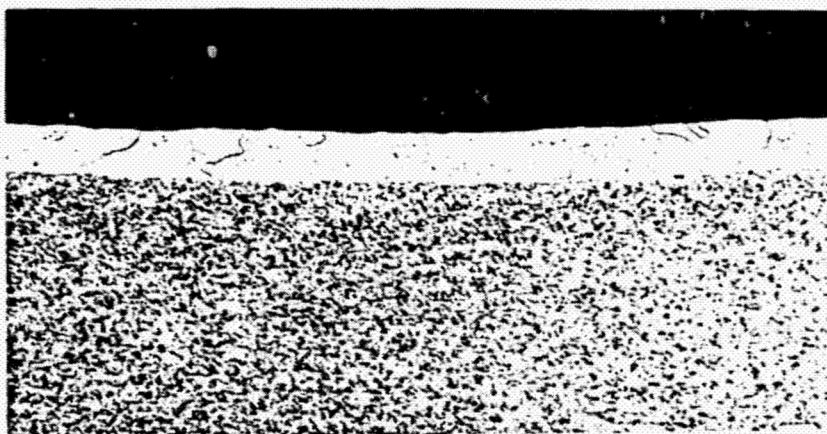
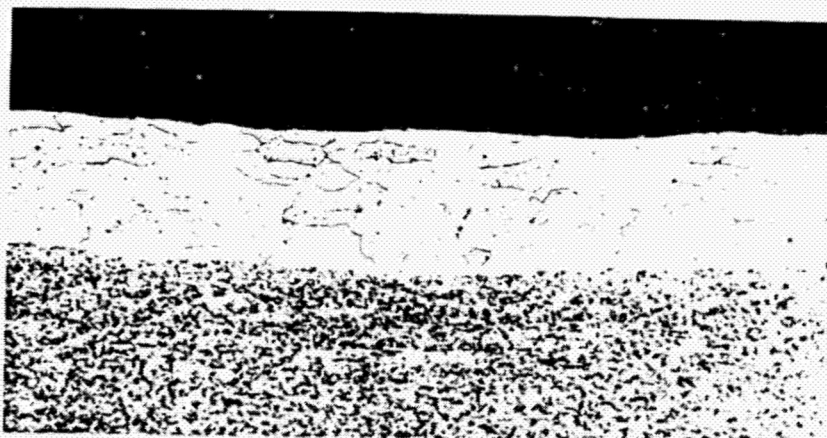
FIGURE 18. RFW tubing, 185 days exposure, typical cross sections. Magnification 100X.

a. Bare 3004 (A-27)  
32 brush passes

b. 5% Alclad 3004 (B-29) Chlorinated

c. 10% Alclad 3004 (C-30) Chlorinated

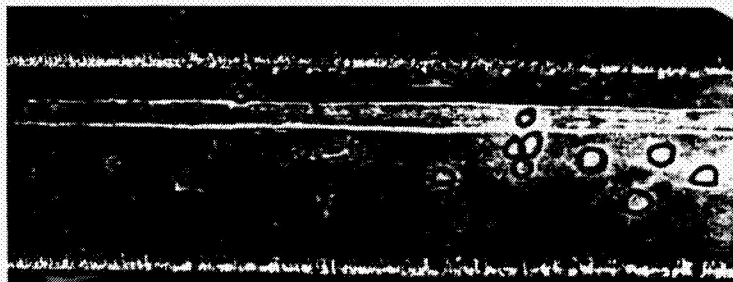
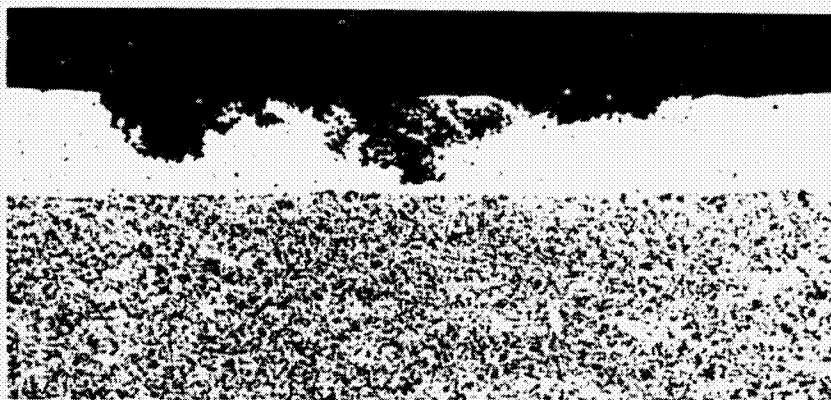
FIGURE 19. Pitting in RFW tubing. Magnification 200X.

Pitting was observed in two instances, both Alclad tubes. Tube C-6 (10% Alclad), exposed for 65 days to chlorinated seawater, had three pits near one end. A cross section of the deepest pit is shown in Figure 19a. The pit is 0.119 mm (4.7 mils) deep and confined to the 7072 clad layer. Figure 19b shows a cluster of pits observed near one end of tube B-30, exposed for 90 days to chlorinated seawater. The deepest pit is shown in cross section in Figure 19c. Depth was 0.061 mm (2.4 mils), and again the pitting was confined to the clad layer.

Deepest pit of  
three pits  
observed

Pit depth - 4.7  
mils. Pitting is  
confined to 7072  
clad layer.

b. 5% Alclad 3004 (B-  
30)

90 d., chlorinated

Cluster of pits  
near one end of  
tube.

c. Transverse cross  
section deepest  
pit in (b) above

Pit depth - 2.4  
mils. Pitting is  
confined to 7072  
clad layer.

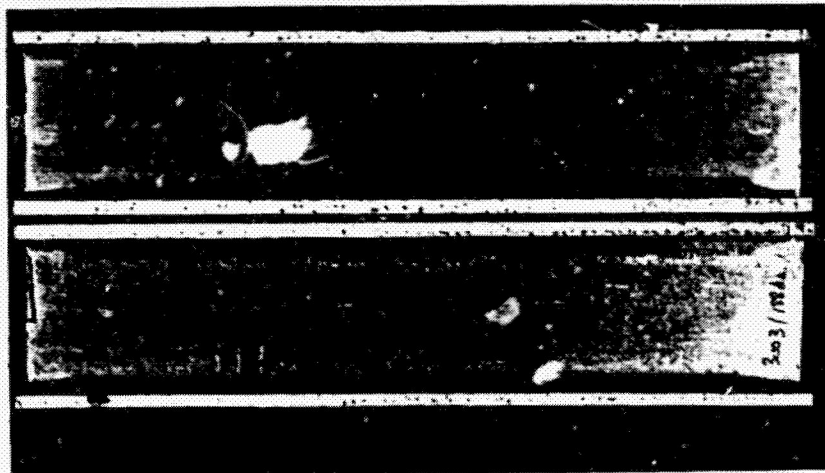
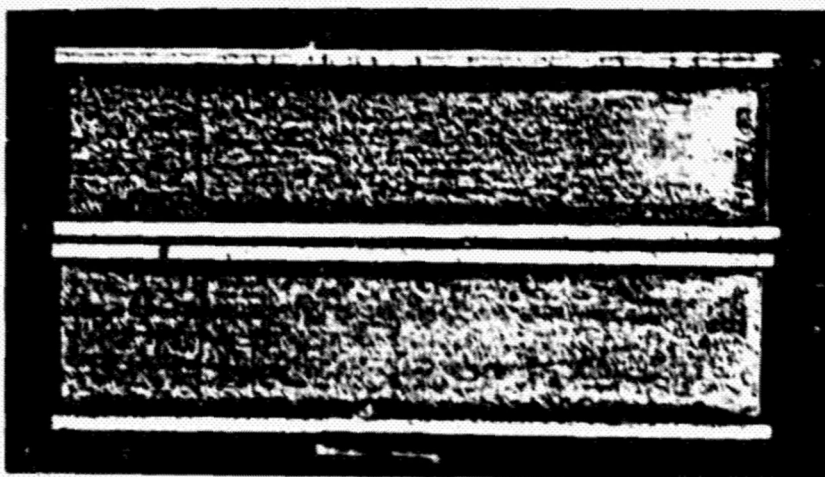
FIGURE 21. Surface appearance, Trane 3003 extrusions, 185 days exposure. Magnification 0.7X.

9.1.2.2 TRANE EXTRUSIONS. Although Figure 14 demonstrates that all Trane materials except the FB-ZN-FE type exhibited comparable corrosion rates after six months exposure, there were marked differences in the mode of surface attack. The flux-brazed bare 3003 samples corroded uniformly, without pitting. The two low-zinc etched types (FB-ETCH-1/2 ZN, FB-ETCH-1 ZN) showed occasional shallow, scattered pitting, but the surface appearance overall was similar to that of the bare 3003. The FB-ZN type (2% ZN at the surface) showed more frequent shallow pitting, the pits strung out longitudinally. The VB-ZN type was more susceptible to pitting, with longitudinal grooving of the tube, often more severe along the bends and at the tube

Figure 21a-d displays macrophotos of four varieties of the Trane extrusions after 185 days exposure, and Figure 22a-c displays 2X photos of typical surface condition for the three zinc protected types most susceptible to pitting attack. Figure 23a-d displays transverse metallographic cross sections of four of the Trane extrusions. Note particularly the broad, deep (0.198 mm or 7.8 mils) pitting in the VB-ZN sample, and the intergranular attack in the FB-ZN-FE variety.

a. FB-Bare 3003 (11)

b. FB-Zn 3003 (FG-2)  
Chlorinated

c. VB-Zn 3003 (ZV-10  
chlorinated

d. FB-Zn-Fe (F-10-2  
Chlorinated

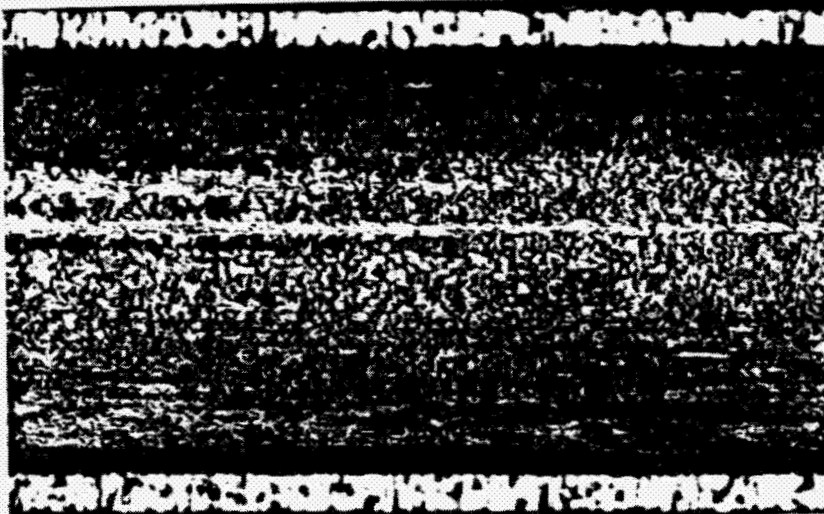
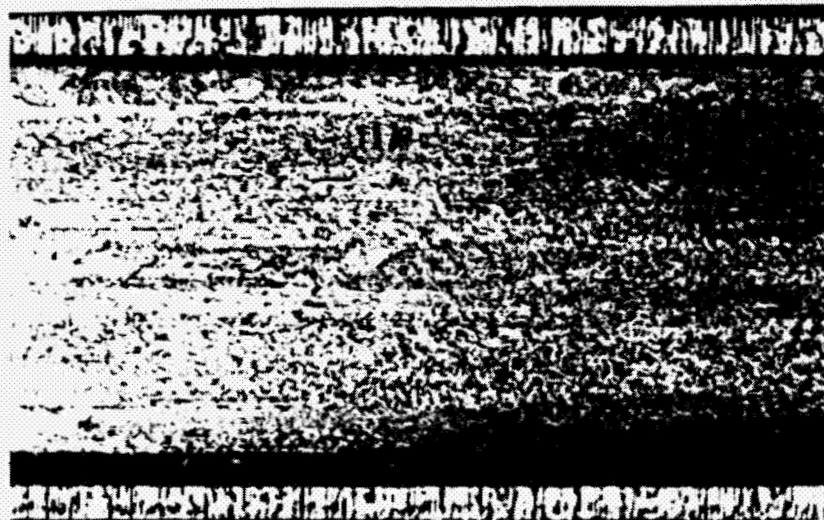
FIGURE 22. Surface appearance, Trane 3003 extrusions, 185 days exposure. Flow direction left to right. Magnification 2X.

a. FB-Zn (GF20-2)  
Chlorinated

b. VB-Zn (AV16-2)  
Chlorinated

c. FB-Zn-Fe (F14-2)

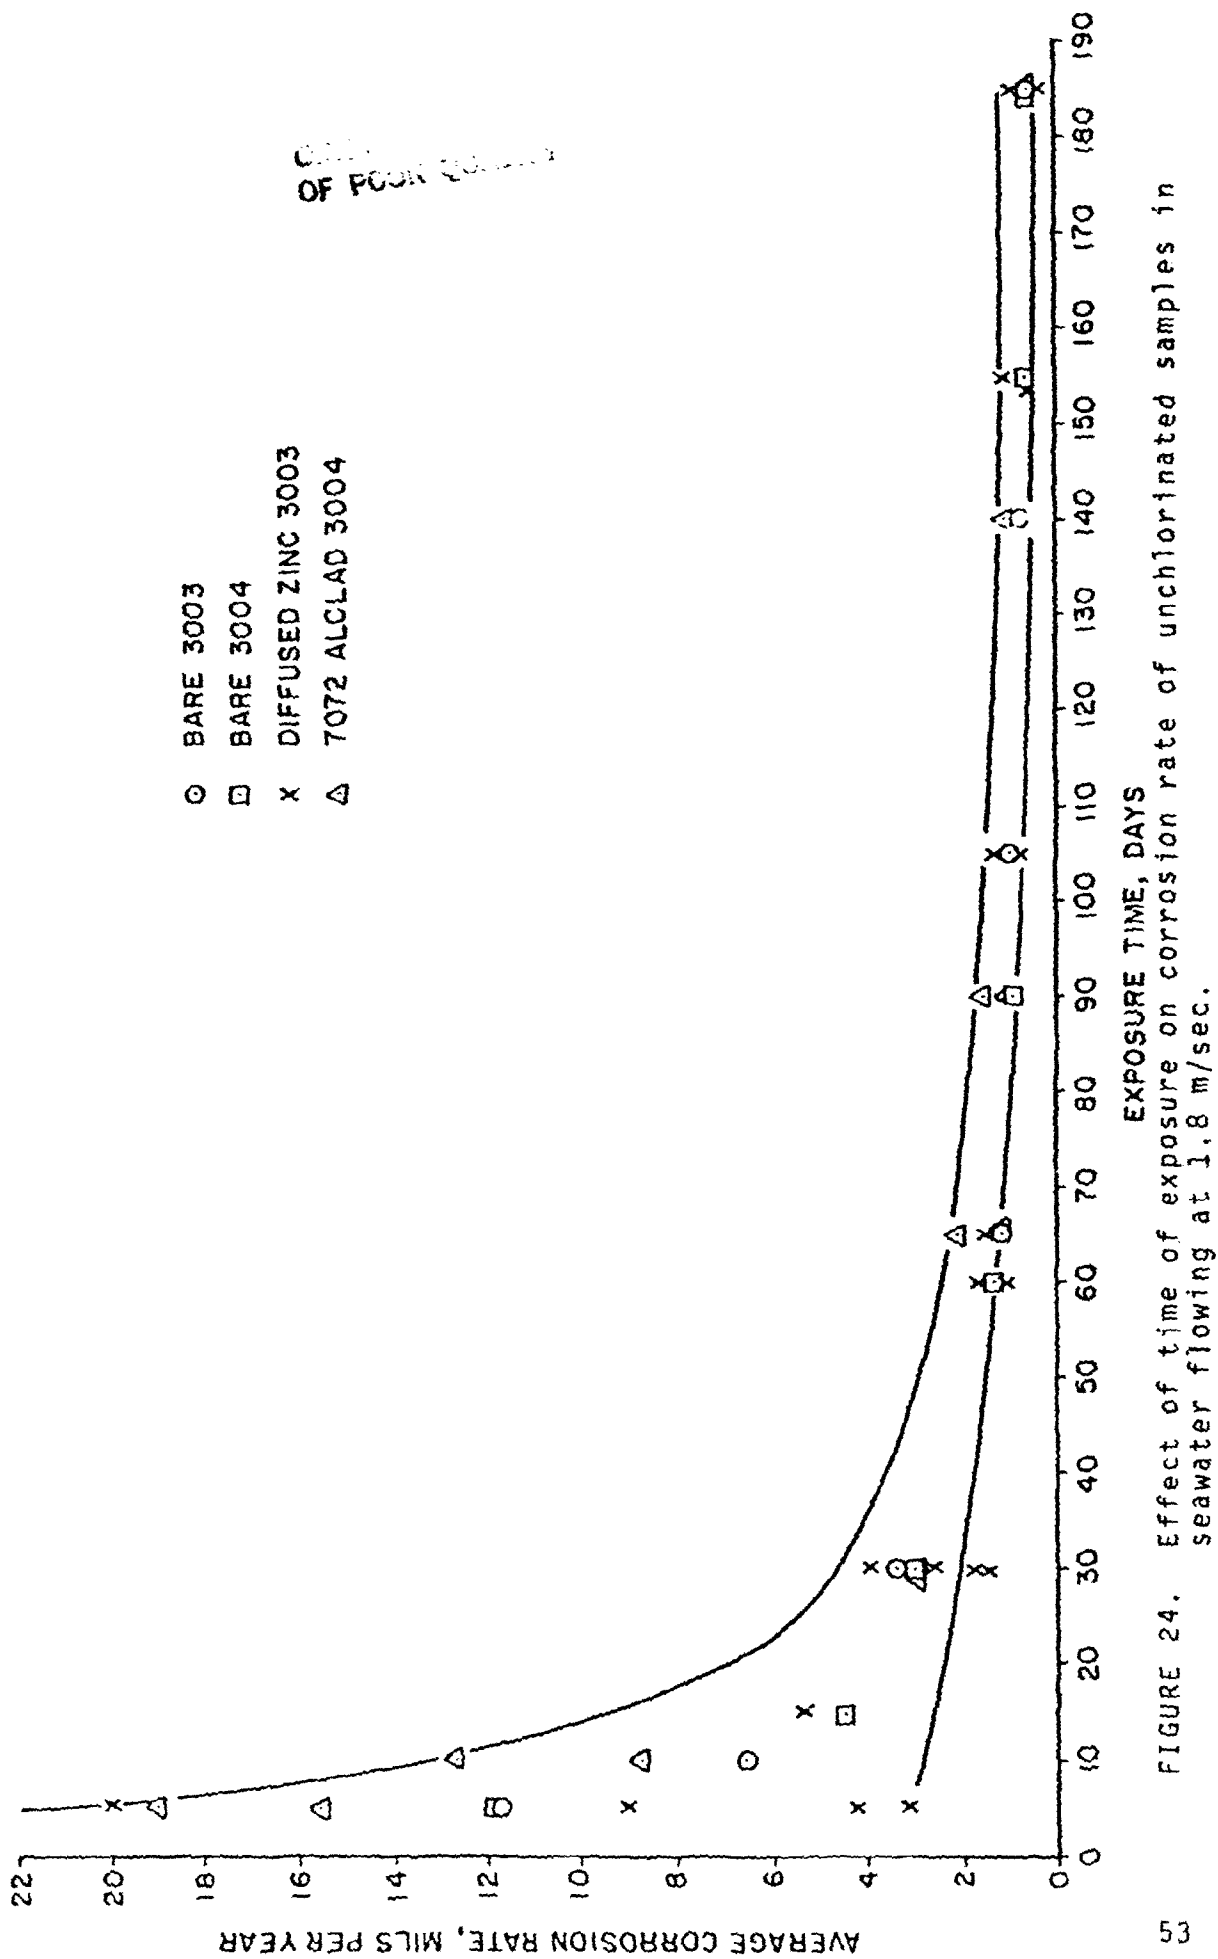
9.2.1 ALL MATERIALS. Corrosion rates of samples exposed to unchlorinated sea water are shown in Figure 24 and are given in Table 5. As shown in Figure 24 corrosion rates of all the aluminum materials varied widely after 5 days but converged rapidly to a narrow range after about 30 days. Corrosion rates of all the materials declined to 0.013 to 0.025 mm/yr (0.5 to 1.0 mil/yr) after 185 days exposure. This marked decrease in corrosion rates with increasing exposure time is in good agreement with previous tests on sea water corrosion of aluminum alloys. Corrosion data for FB-ZN-FE material were not included in Figure 24 because average corrosion rates do not properly represent this material that had significant intergranular corrosion.

The data in Figure 24 for Bare 3003 and Bare 3004 determined by Trane and by Kaiser, respectively, are in excellent agreement. This agreement shows that procedures used by the two laboratories produced comparable results.

Figure 24 also shows that corrosion rates of all the materials were not affected by periodic brushing to remove

FIGURE 24. Effect of time of exposure on corrosion rate of unchlorinated samples in seawater flowing at 1.8 m/sec.

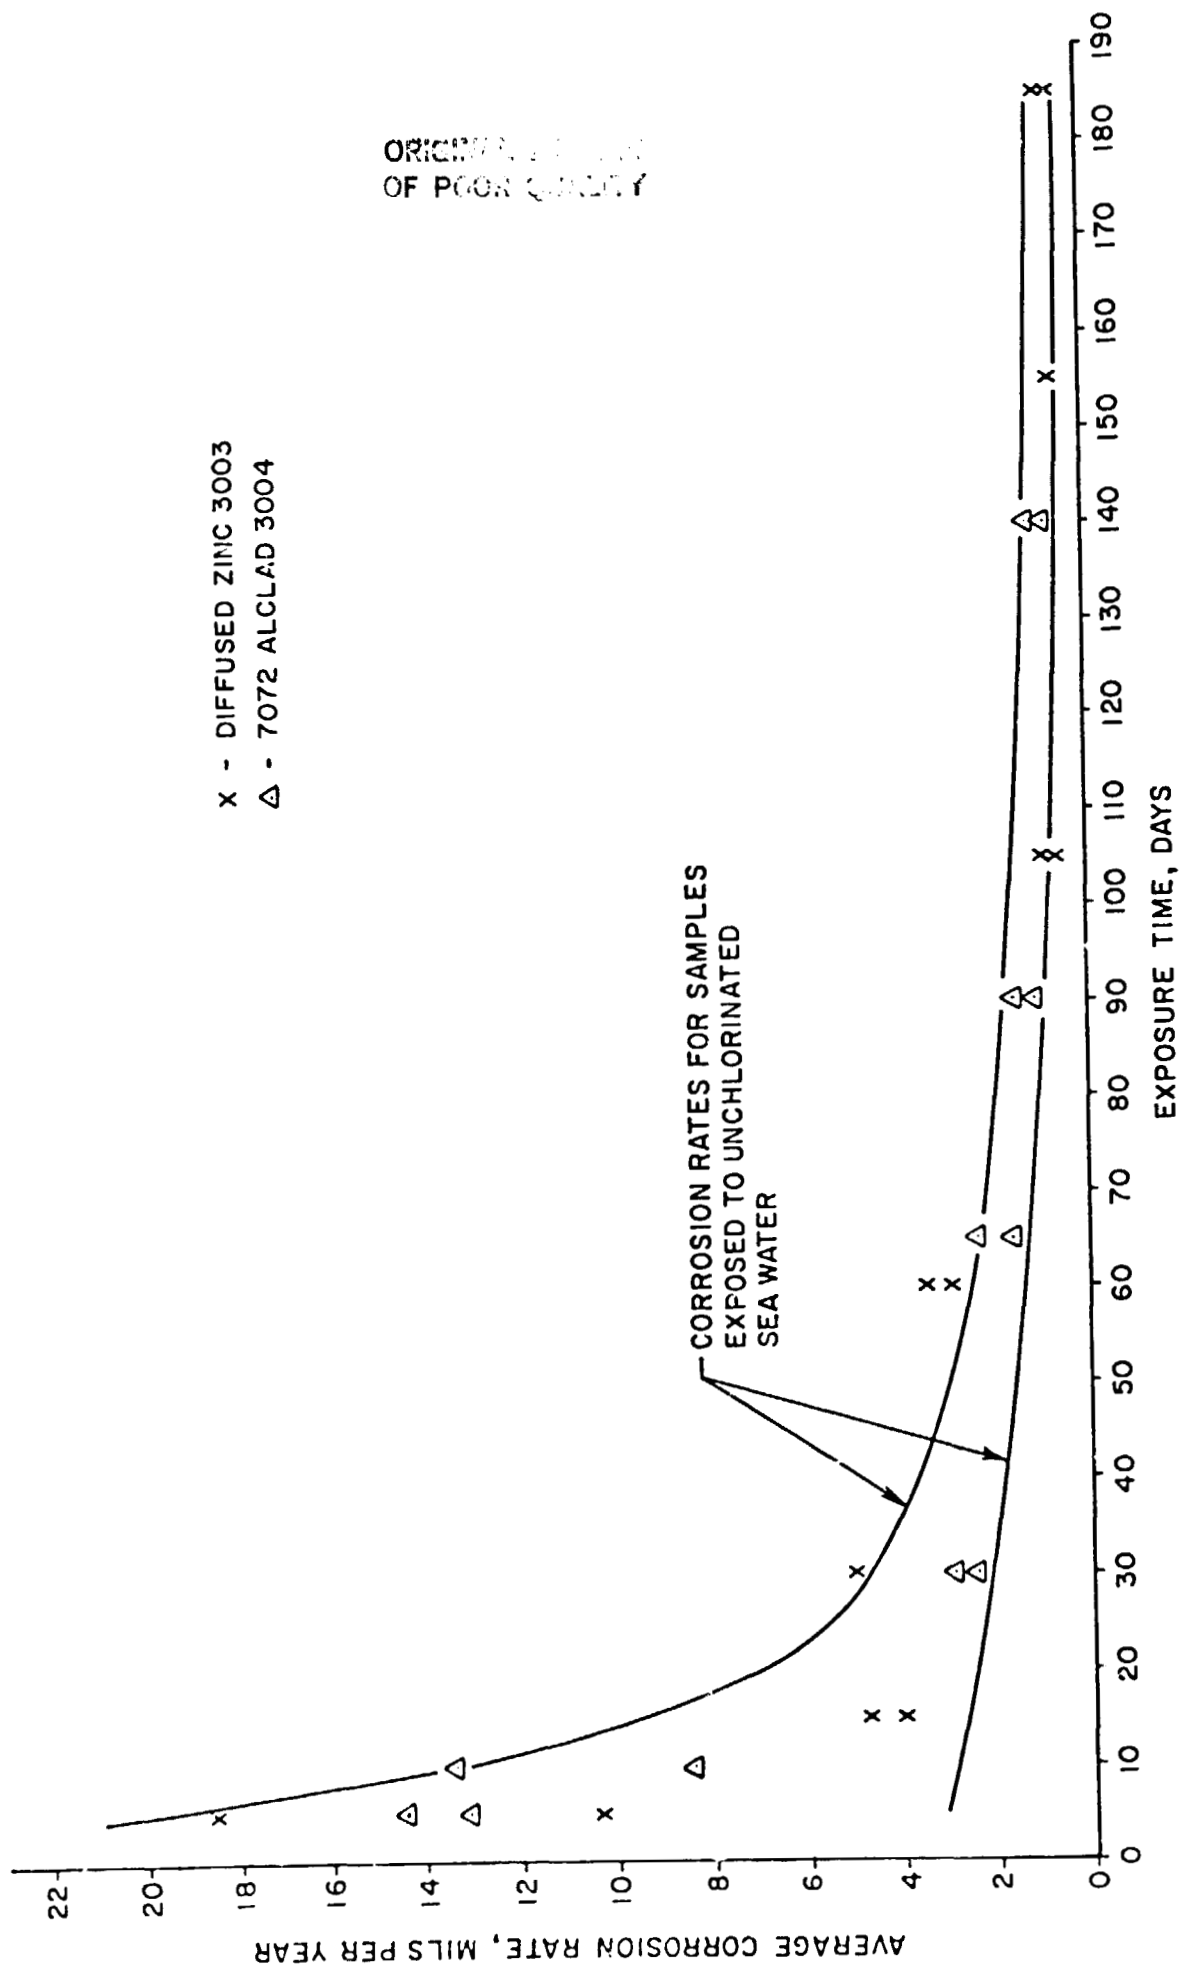
Similarly, corrosion rates of the 3003 with diffused zinc and of 7072 alclad 3004 materials were not affected by chlorination at 0.5 ppm for 28 minutes per day to prevent biofouling as shown in Figure 25.

FIGURE 25. Effect of chlorination on corrosion rate of 3003 with diffused zinc and of 7072 Alclad 3004.

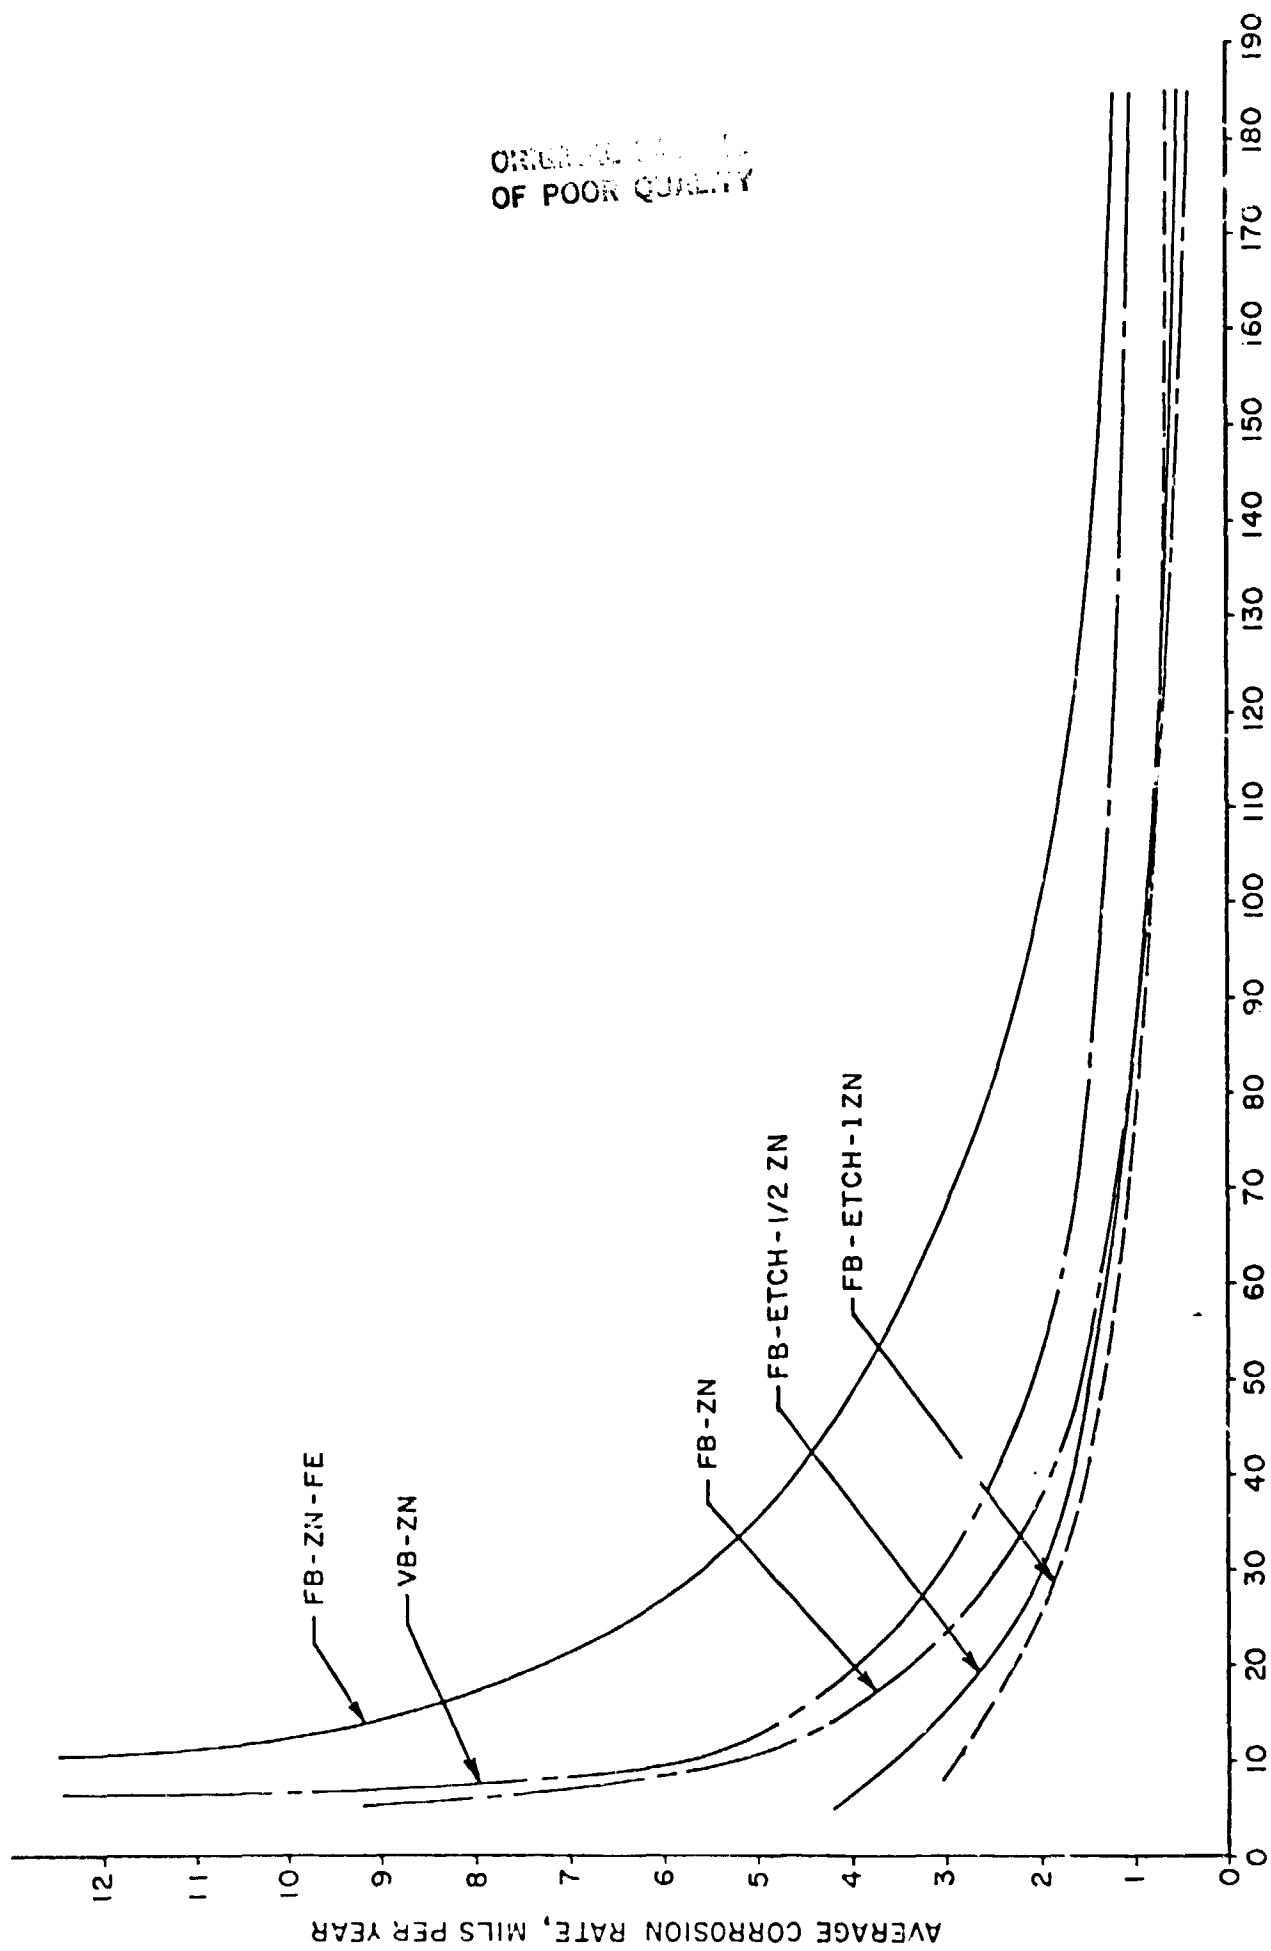
9.2.2 3003 WITH DIFFUSED ZINC. Corrosion rates for samples with diffused zinc are shown on an expanded corrosion rate scale in Figure 26. As shown in Figure 26, initial corrosion rates for the FB-ZN material were significantly higher than corrosion rates for the FB-ETCH-1/2 ZN and FB-ETCH-1ZN materials. However, corrosion rates for all three materials declined to similar low values after about 40 days exposure. The higher corrosion rate for the FB-ZN material probably resulted from increased corrosion of the surface layer with about 45% zinc and from slightly more pitting attack compared with the etched samples. That the samples with diffused zinc contents ranging from less than 0.5% to about 2% near the surface corroded at similar rates after extended exposure time shows the rate is insensitive to zinc content in the range studied. (However, after pits penetrate the diffused zinc layer subsequent corrosion rates of the layer by galvanic action will probably depend on the zinc concentration).

FIGURE 26. Effect of time of exposure on corrosion rates of 3003 with diffused zinc.

Corrosion rates for the VB-ZN material were slightly above rates for the FB-ZN materials for all exposure times. However, the difference in corrosion rates is not considered sufficiently great to preclude use of the vacuum brazing process for fabricating heat exchangers. Cause of the slightly higher corrosion rate for the vacuum brazed material was not determined.

The apparent corrosion rate curve for the FB-ZN-FE material is included in Figure 26 to illustrate that apparent corrosion rates for the zinc diffused layer with low iron content were significantly above rates for the FB-ZN material with a similar zinc concentration but without addition of iron. Low iron content in the diffused zinc layer in aluminum did not retard sea water corrosion as residual iron in zinc anodes does.

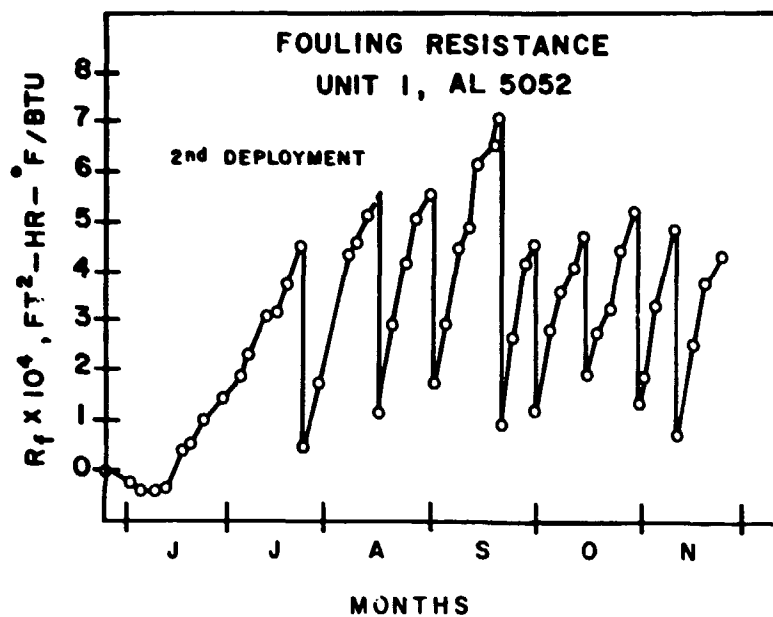
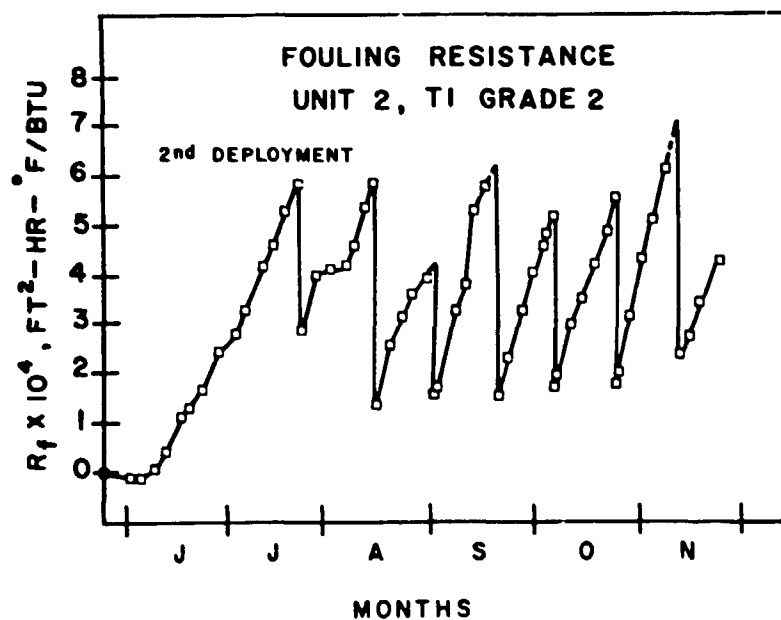
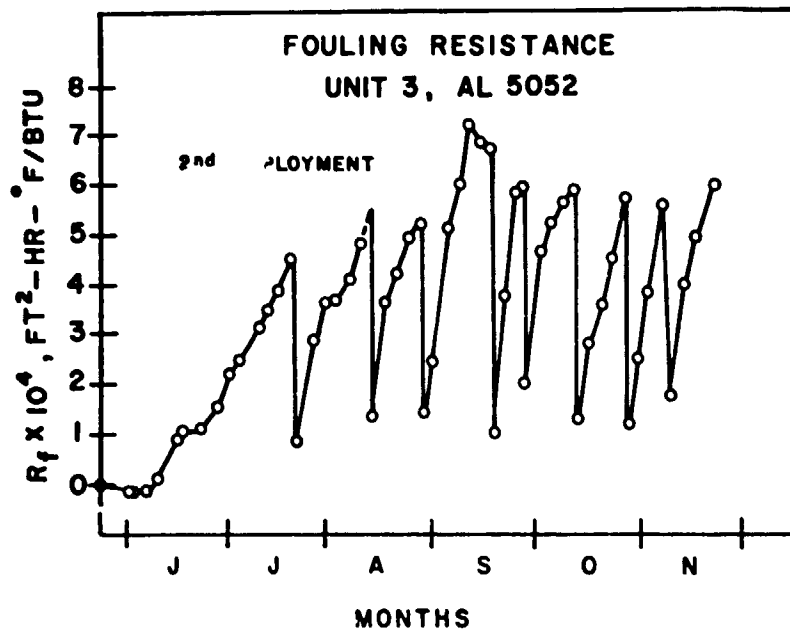
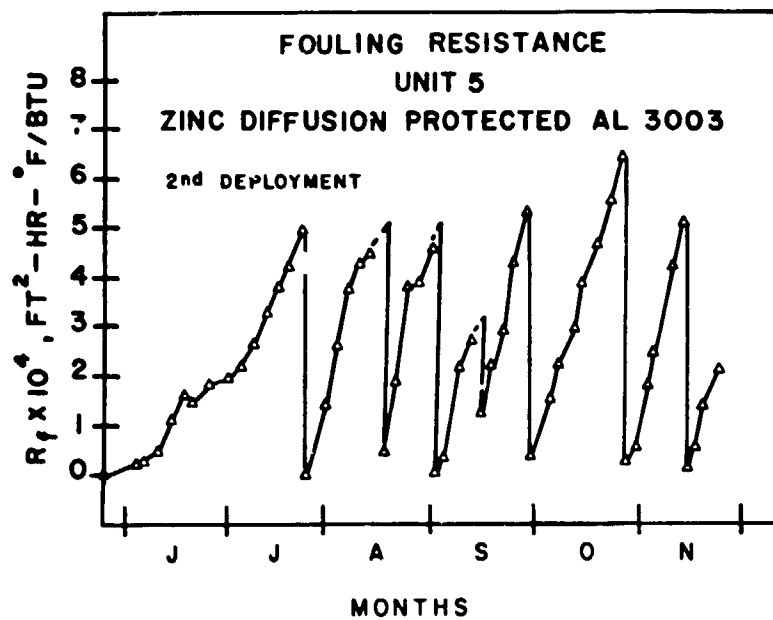
10.1 RESULTS. Figure 50 shows the results of the fouling resistance ( $R_f$ ) measurements for the unchlorinated units. These data appear in Appendix 1. At the onset of the experiment, there was an initial induction period during which  $R_f$  values remained near zero or were even slightly negative. All units had an induction period of about two weeks, with that of the titanium unit being slightly shorter than those of the aluminum units. It is believed that this induction period is the result of patchiness in microbial growth during the early colonization stages (14).

Following the induction period and following each cleaning,  $R_f$  increased almost linearly with time (Figure 50). The fouling rates,  $dR_f/dt$ , obtained from the slopes of the fouling resistance curves of Figure 50 are shown in Figure 51 (see also Appendix 2). This Figure shows the near zero and sometimes negative fouling rate for the induction period, the slow increase in fouling rate during the transition period, and the steady state fouling rate of  $0.046 \pm .004 \text{ m}^2\text{-}^\circ\text{K/W-day}$  ( $0.26 \text{ ft}^2\text{-hr-}^\circ\text{F/Btu-day}$ ) after 80 days. No significant difference in the fouling rate was observed between the titanium HTM, the two aluminum HTM's, and the STM.

FIGURE 50. Fouling resistance measurements for unchlorinated Heat Transfer Monitoring units showing cycles of growth and cleaning.

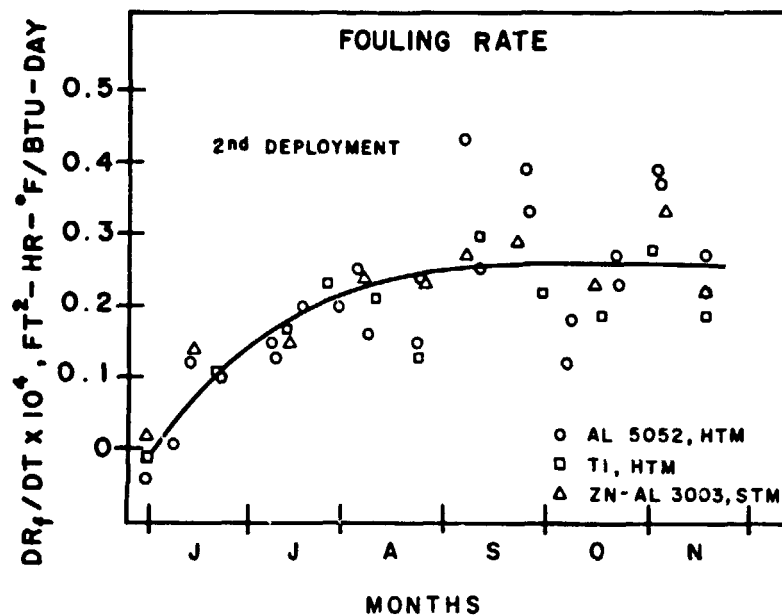
FIGURE 51. Fouling Rates ( $dR_f/dt$ ).

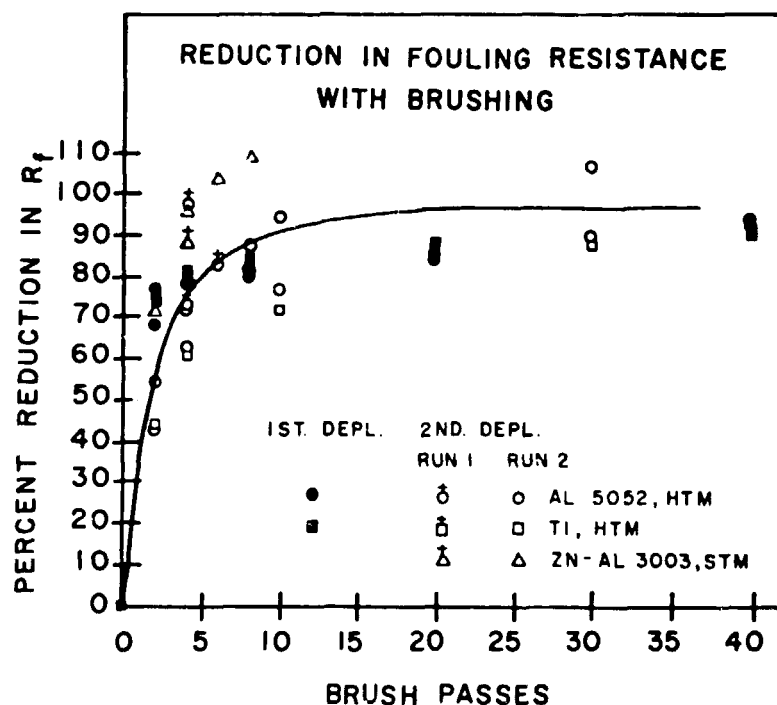
FIGURE 52. Percent reduction in thermal resistance by cleaning with manually operated brushes.

Figure 52 gives a summary of the effectiveness of brush cleaning for both the first and second deployments. Two brush passes were sufficient to reduce  $R_f$  by two-thirds, and ten passes reduced  $R_f$  by approximately 90 percent. However, only in the early stages of the experiment was it possible to approach an  $R_f$  value of zero by brush cleaning. This suggests that the fouling resistance was caused by two distinct biological layers: an upper layer which was removed easily by brushing, and a hard, bottom layer (possibly exuded polysaccharides) which accumulated slowly and could not be removed by brush cleaning.

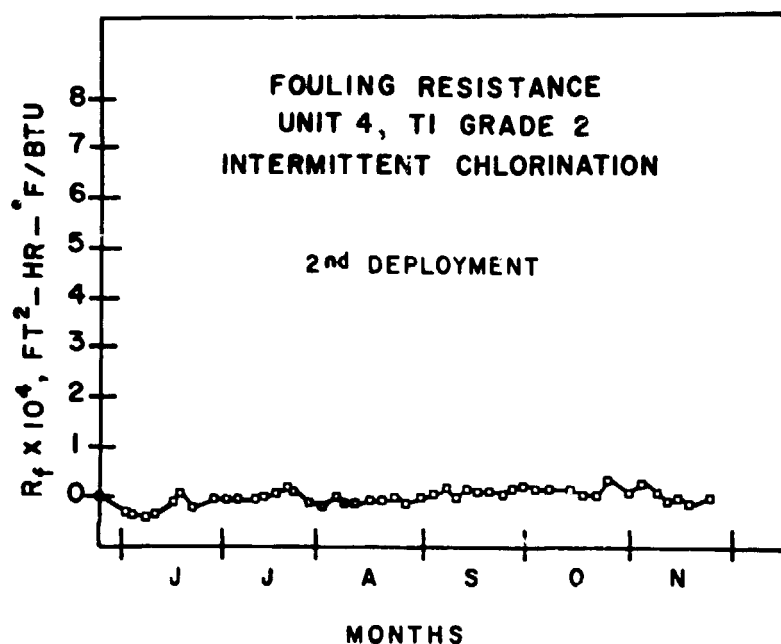
Intermittent chlorination performed on unit four proved to be an effective method of biofouling control (Figure 53). The  $R_f$  value for unit four during the entire six months of the second deployment remained essentially at zero.

FIGURE 53. Fouling resistance of the chlorinated Heat Transfer Monitoring unit.

The level of chlorination administered during this investigation was sufficient to control microfouling of the test surfaces (see figure 53) but did not prevent the development of a macrofouling community in the module of unit 4. This is consistent with the findings of Burton, 1977 (16) who reported that intermittent halogenation is not effective in controlling development and growth of macrofouling communities. There was almost no difference in the number of species found in units 1 and 4 (30 and 31 species, respectively), and unit 4 actually had more biomass than unit 1 (87 g and 66 g, respectively).

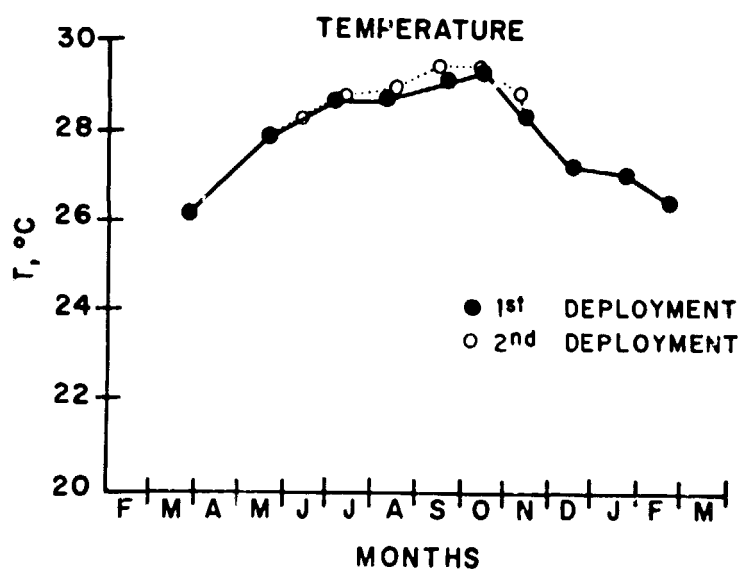
Mean surface seawater temperature during the test period was 29 °C. Figure 54 is a plot of surface seawater temperatures during the test.

FIGURE 54. Surface seawater temperature during the test period.
